Sustainable Vapor Intrusion Controls – Designing an Effective Passive System

James R. Ash, Mark C. Ensign, William F. Simons

GEI Consultants, Inc., 400 Unicorn Park Drive, Woburn MA 01801

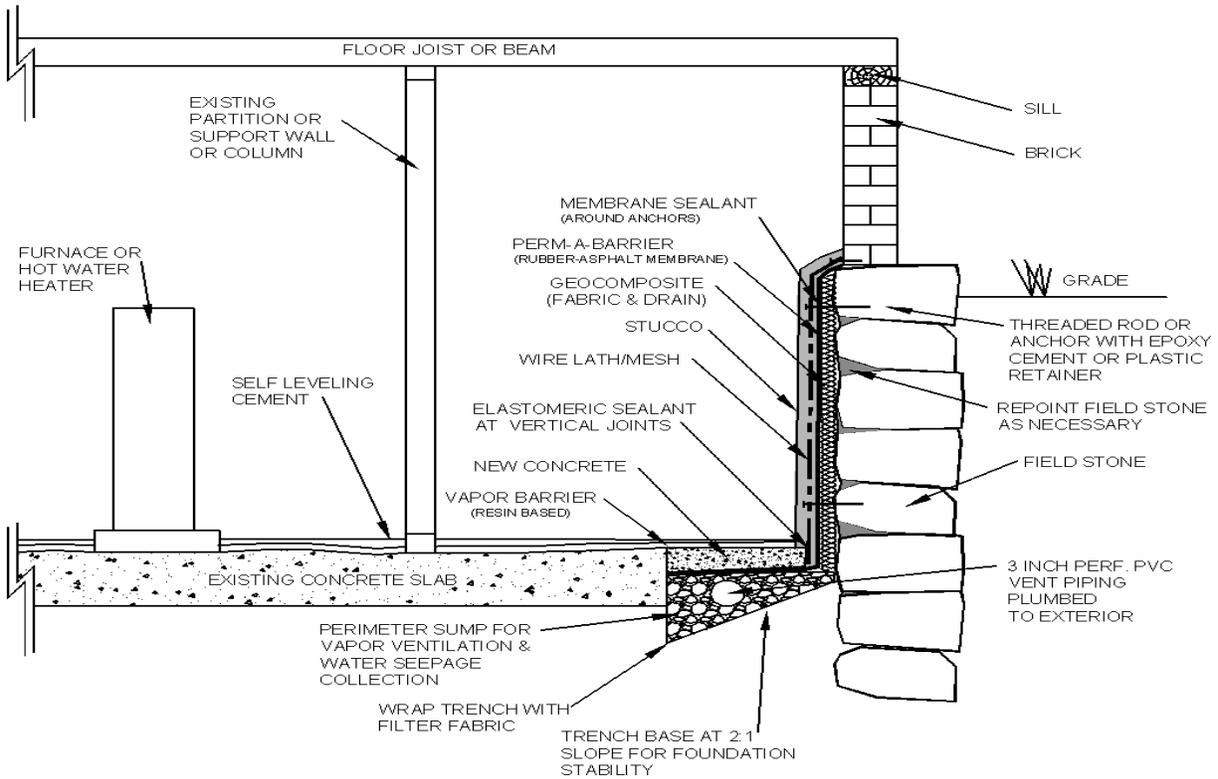
The passive system designed and installed for this property addresses both the foundation floor slab and the foundation walls as vapor intrusion pathways. The perimeter vapor trench and the vapor transmission space on the fieldstone walls allows for the vapor to transmit through the walls but not into the living space. The vapor trench and wall transmission space are vented outside the building envelope using the same piping network that had been installed for the active system. The floor and walls are sealed using an elastomeric epoxy vapor barrier designed for use on new or old clean concrete or cementitious stucco. Figure 1 illustrates the conceptual design for this property.

Figure 1. Residential – Vapor Trench and Epoxy Vapor Barrier Schematic

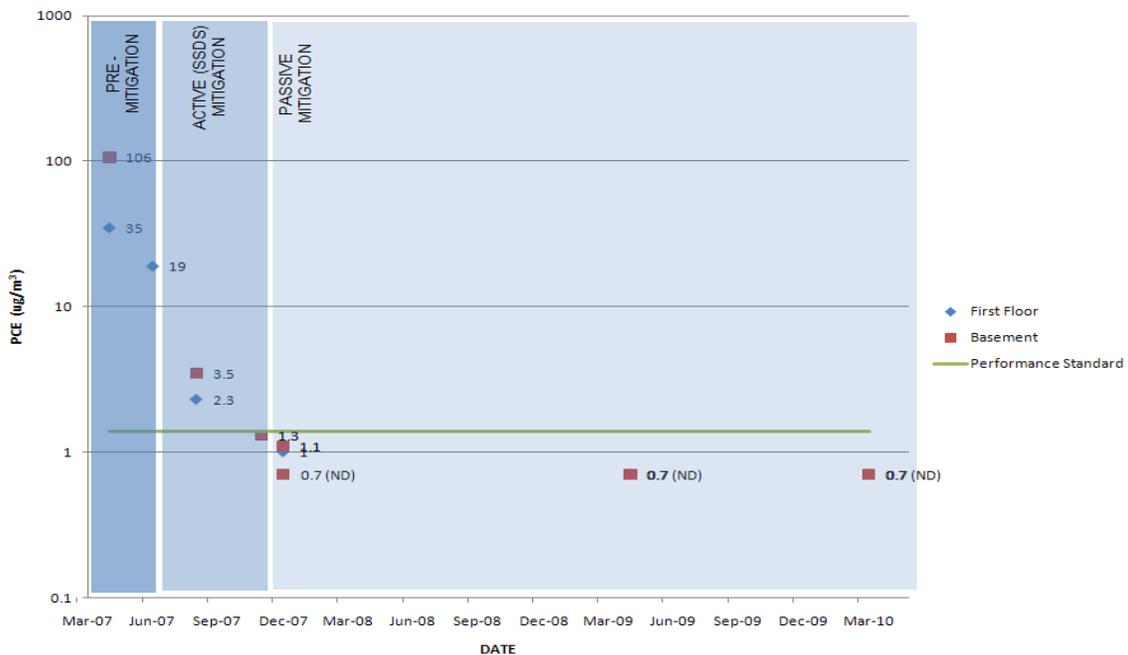
Since installation of the passive system, indoor air concentrations, for both the basement and first floor, have been reported below laboratory reporting limits during three sampling events, two of which were collected in the winter months. Figure 2 presents the pre and post mitigation results.

Figure 2. Case Study 1 – Indoor Air PCE Concentrations

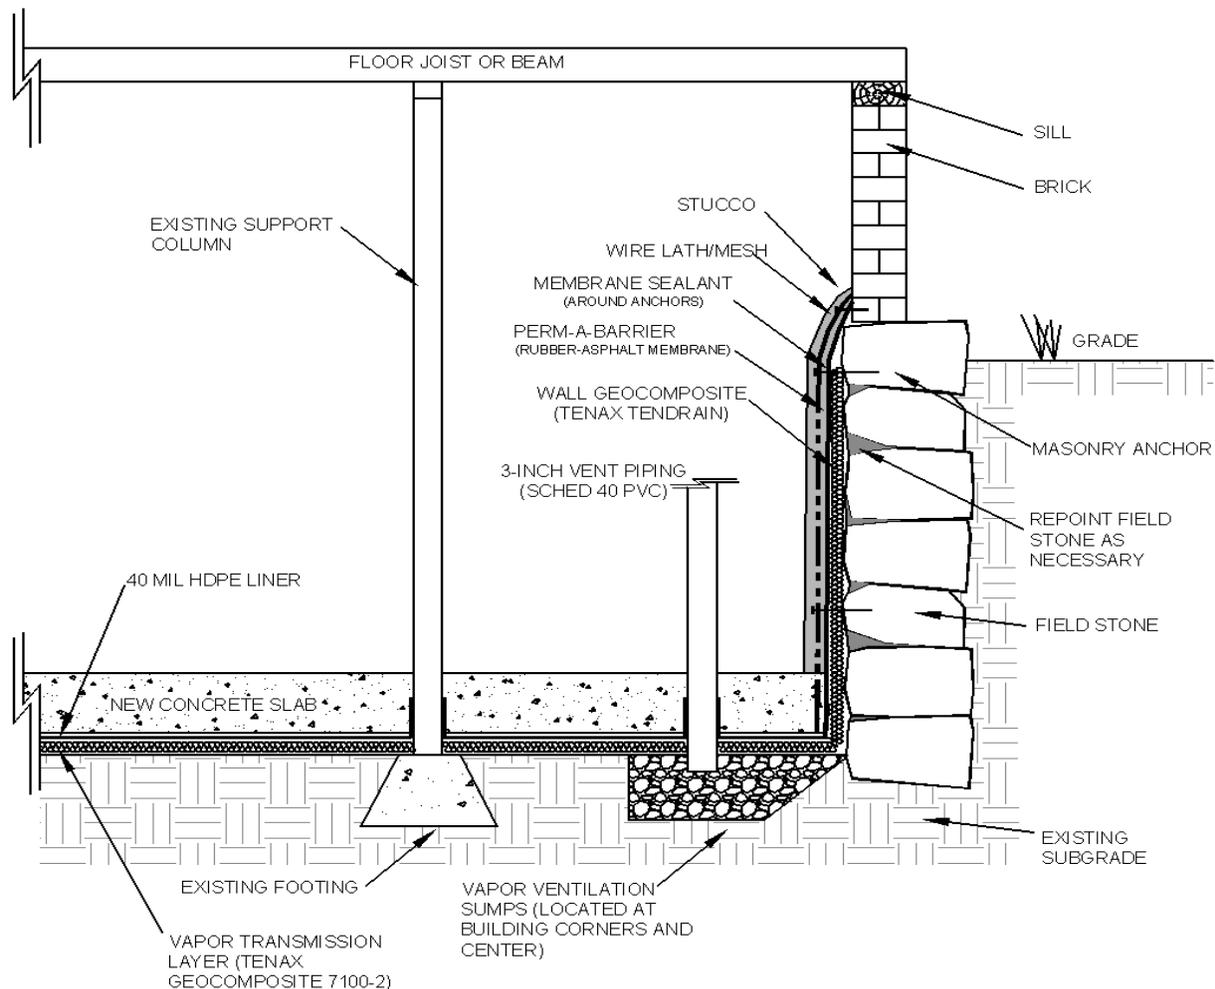
The passive system designed and installed for this property addressed both the foundation floor slab and the foundation walls as vapor intrusion pathways. The sub slab vapor transmission layer in communication with the ventilation piping reduces vapor concentration beneath the barrier. The sub slab vapor transmission layer is vented outside the building envelope using a similar piping network for active systems. The foundation wall system in this example is comprised of anchored wire mesh, cementitious stucco, and an elastomeric vapor barrier coating. Figure 3 illustrates the conceptual design for this property.

Figure 3. Residential – Slab Replacement and Epoxy Vapor Barrier Schematic

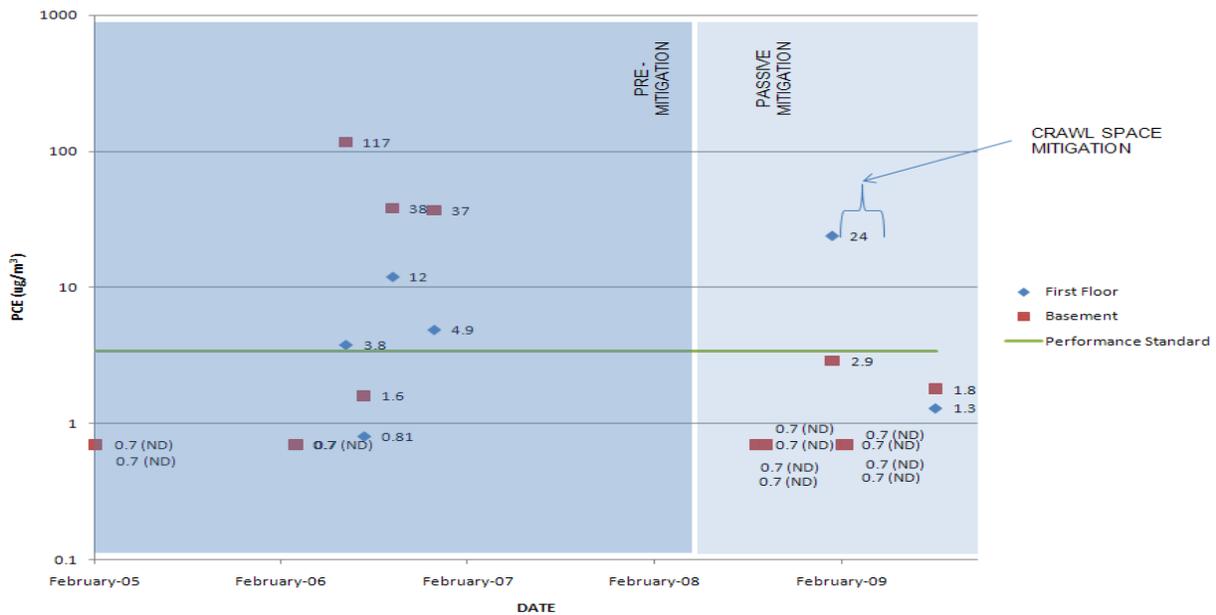
Since installation of the passive system, indoor air concentrations have been reported below laboratory reporting limits during four of six sampling events. Three samples were collected in the winter months. One of the winter samples yielded a much higher concentration on the first floor than the basement which was not observed previously. Upon further inspection of the building, a small crawl space was identified. The crawl space was not accessible and an entryway was installed through the foundation to install a vapor barrier and ventilation piping. Samples collected after installation of the vapor barrier in the crawl space yielded concentrations below the performance standard. Figure 4 presents the pre and post mitigation results.

Figure 4. Case Study 2 – Indoor Air PCE Concentrations

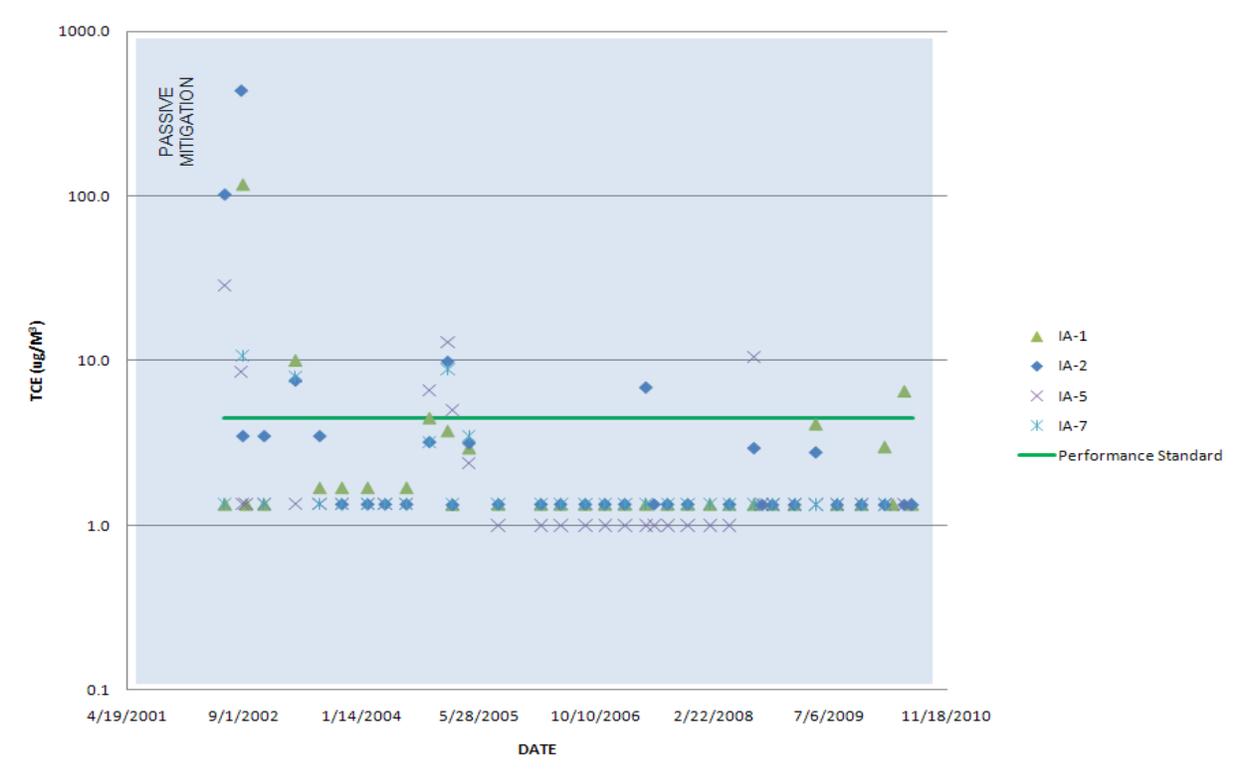
the concrete foundation wall using a strip of two-sided polymer adhesive tape. To allow for sub-slab ventilation, and the addition of a potential future active blower system, slotted PVC pipe was placed in gravel filled trenches through the old slab and connected to PVC risers that discharged above the roofline. The system has been in place for more than 5 years, operated in passive mode, and has been successful in eliminating indoor air detections of chlorinated solvents. Initial post mitigation concentrations were attributed to passive vents discharging too close to rooftop Heating, Ventilation, and Air Conditioning (HVAC) system air intakes. Figure 5 presents the post mitigation results.

Figure 5. Case Study 3 – Indoor Air TCE Concentrations
